FACILITY ASSESSMENT REPORT SPRINGFIELD PUBLIC SCHOOLS

Springfield, Minnesota

February 16, 2016

Project #16-18829

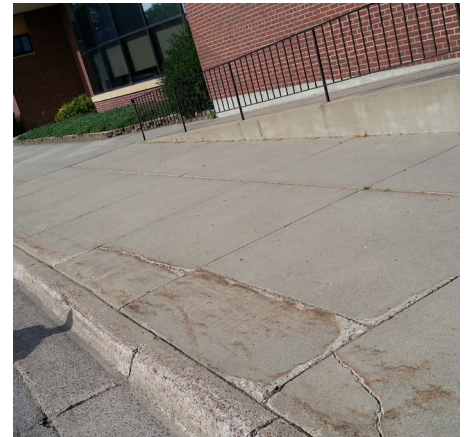
- The east sidewalk near the northeast corner of the block shows signs of deterioration. Large cracks, spalling, and discoloration of concrete are due to normal wear and potential salt erosion (see Figure 1).

Figure 1 - East sidewalk existing conditions

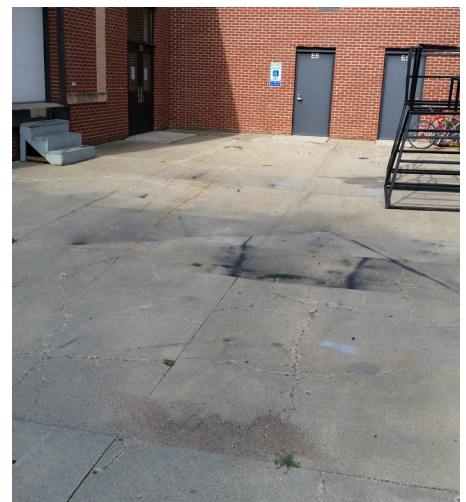
- The east side of the building has a bay for truck deliveries with access to the Shop and Theater. The concrete in this area is sunken and cracked due to heavy equipment and delivery trucks unloading and parking here. When this concrete pad was originally placed, it was most likely not designed for present-day heavy equipment and large deliveries. It was not reinforced to accommodate the increased load, resulting in settled concrete and cracks (see Figure 2).

Figure 2 - East side truck loading area concrete conditions

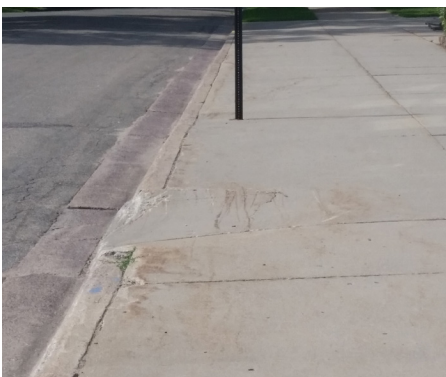
- In front of the High School entrance on the east side is an accessible ramp that shows signs of deterioration requiring repair (see Figure 3).
- Cracks, spalling, and stained concrete are apparent on the west concrete walk outside of door W8. This location is in need of new concrete walks and concrete curbs (see Figures 4 and 5).

Figure 3 - East side sidewalk accessibility ramp

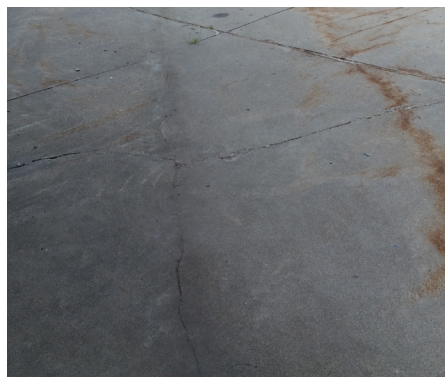
Figure 4 - West side sidewalk condition

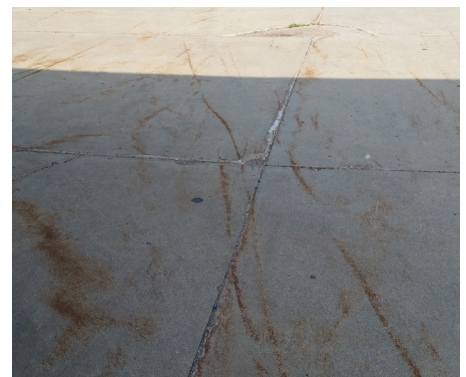
Figure 5 - West side sidewalk condition

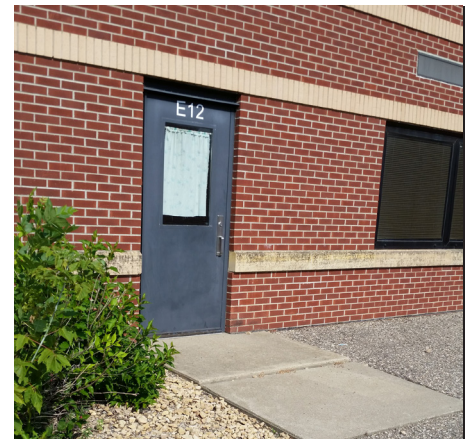
Figure 6 - Entrance at door E12

- At entrances E12 and E13, uneven concrete is an accessibility concern for students entering the playground (see Figures 6 and 7).

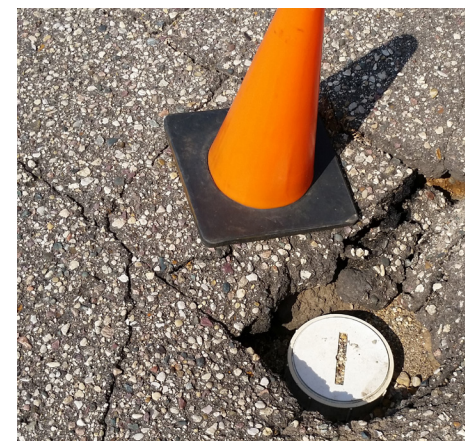
- The playground equipment designed for the Elementary School is in very good condition and promotes “Tiger Pride” using maroon and gold colors (see Figure 8).
- The surrounding asphalt is in poor condition with cracks, patching, and an overall uneven surface. There is an area near the north basketball hoop where an 8” hole is marked by a cone. This hole poses a safety concern to students playing in that area (see Figure 9).

Figure 9 - Clean-out hole safety hazard in asphalt paving

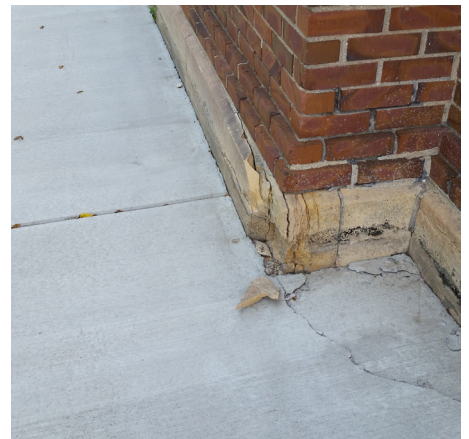
Figure 21 - Deteriorating exterior stone on west side near Gym

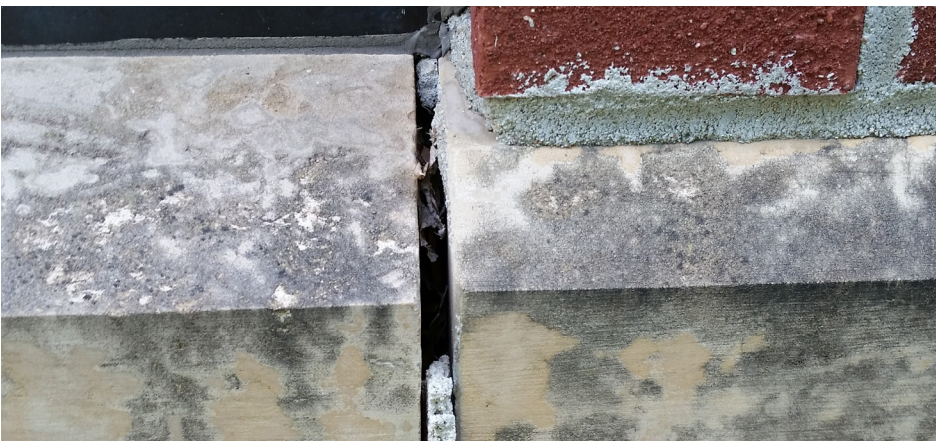
Figure 23 - Deteriorating grout

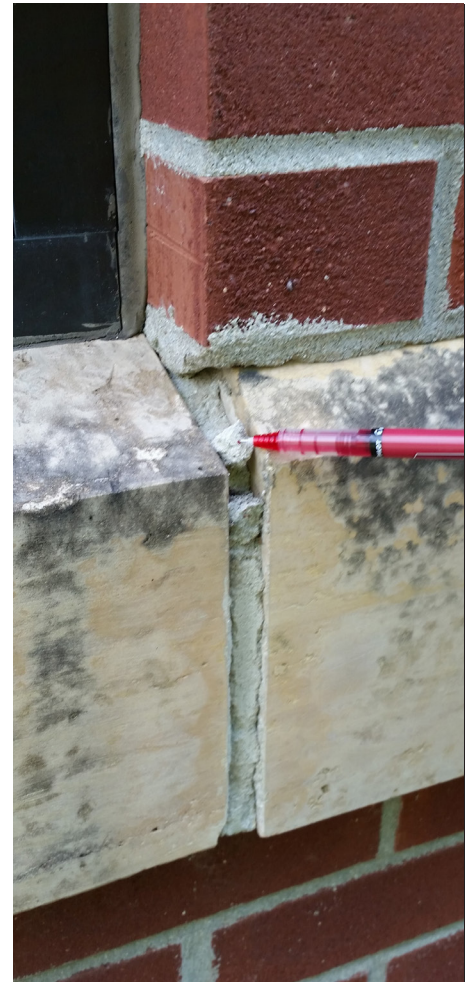
Figure 22 - Deteriorating grout

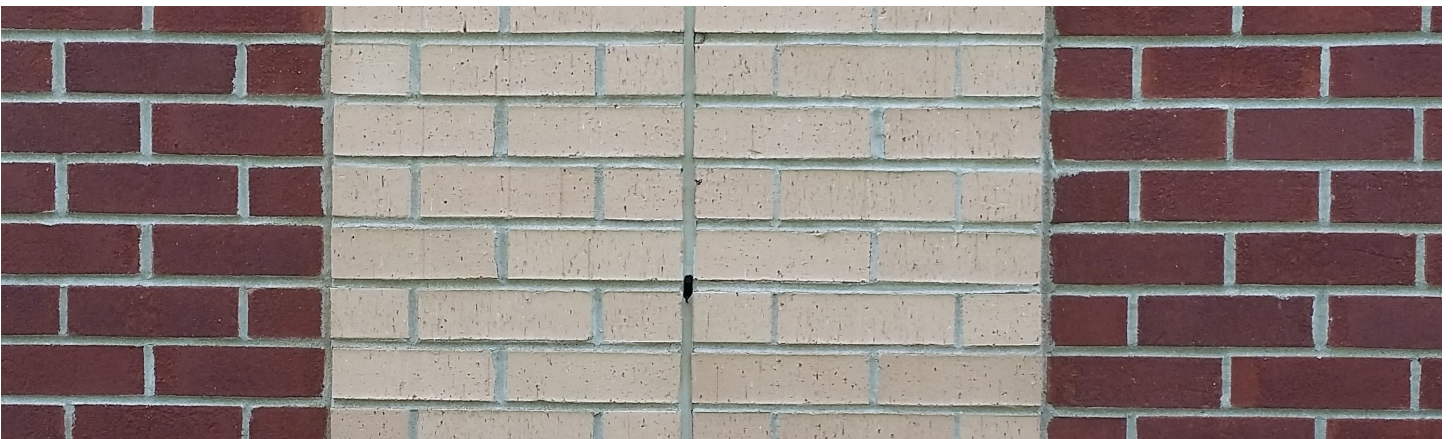
Figure 24 - Void in exterior caulk joint

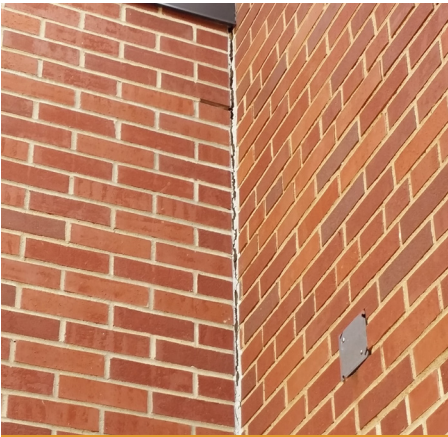
Figure 25 - Voids in exterior caulk joint

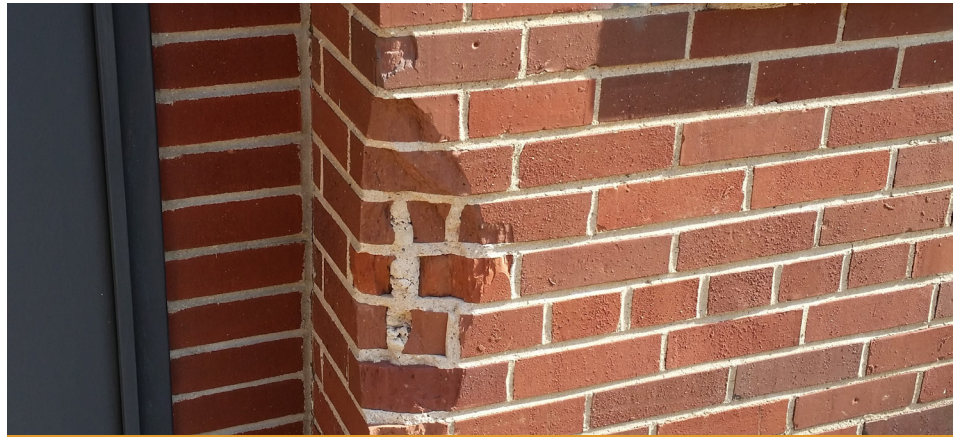
On the east side of the building, in the truck loading dock, brick has been damaged due to being struck by vehicles (see Figure 26). Brick replacement can be performed to return the brick to its original appearance. In some locations, cracks in the brick are four to ten feet long. At these locations tuckpointing is recommended, which will significantly reduce further damage (see Figures 27 and 28).

Figure 26 - Existing brick conditions

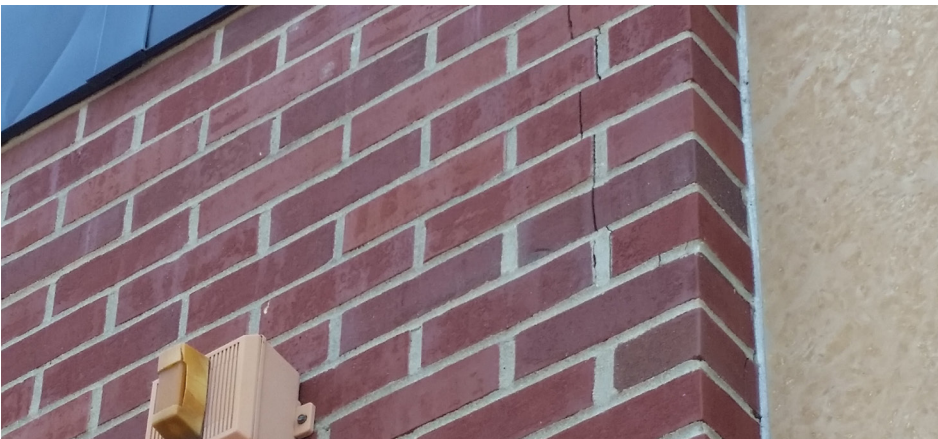
Figure 27 - Cracked brick location

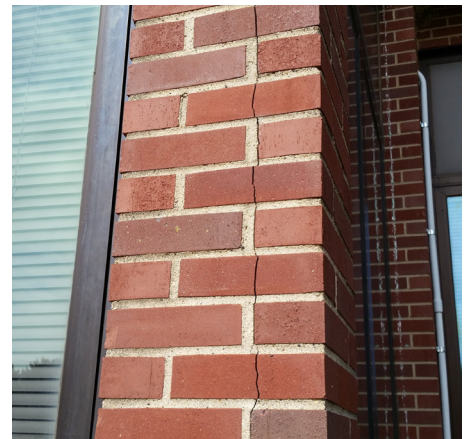
Figure 28 - Cracked brick location

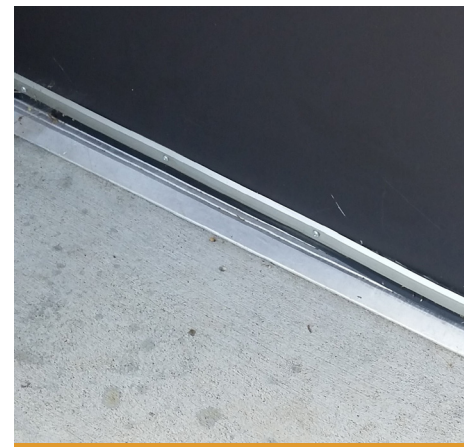
A door on the north side of the building poses a safety issue since the metal sweep at the bottom is bent back and sticking out. Replacement of the sweep would resolve the issue (see Figure 33). Many of the existing exterior doors are in need of weather seal replacements.

Figure 33 - Damaged mounting track for sweep

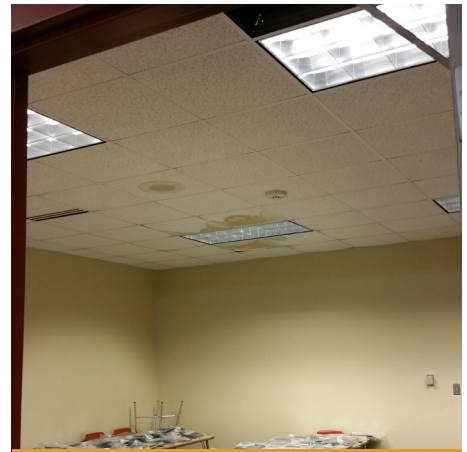
Wall paint in classroom locations is in good condition and does not require much more than continued maintenance. Minor touch up can be provided by school staff as necessary. In many locations, acoustical ceiling tiles (ACT) are stained from past roof leaks. These tiles should be removed and replaced to provide the school with improved appearance (see Figures 39 and 40).

Figure 39 - Stained ceiling tiles

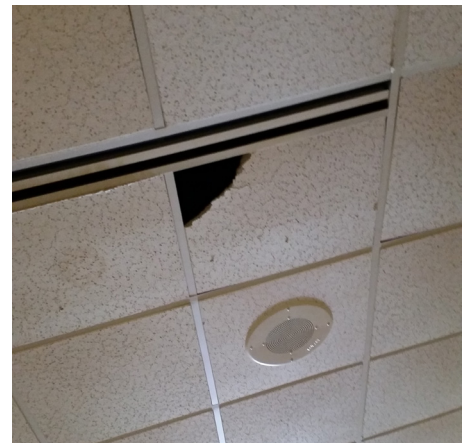
Figure 40 - Broken ceiling tile

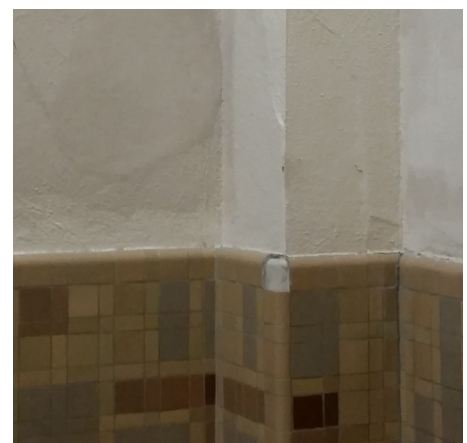
The stairway on the north wing of the building has tile on the walls that has broken off and needs replacement. There is also a patch on the wall that needs to be cleaned and painted to blend better into the existing wall (see Figures 43).

Figure 43 - Existing stairwell landing wall finishes

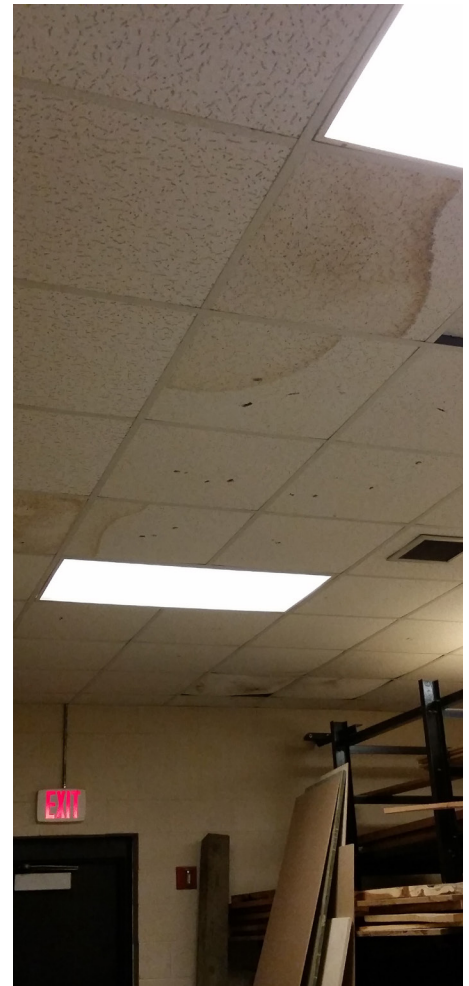
Throughout the building, there are multiple stained ceiling tiles that need to be replaced. Replacing stained tiles will help determine which areas have current moisture problems and what roof leaks were previously resolved (see Figures 61 and 62).

Figure 61 - Stained ceiling tiles

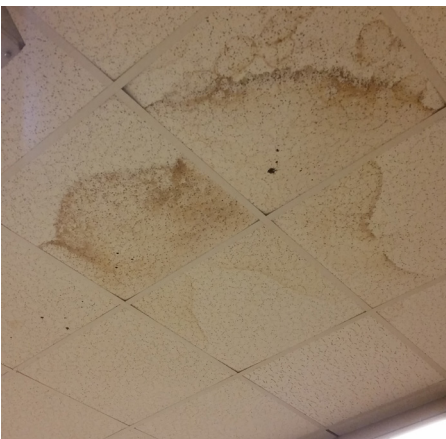
Figure 62 - Stained ceiling tiles

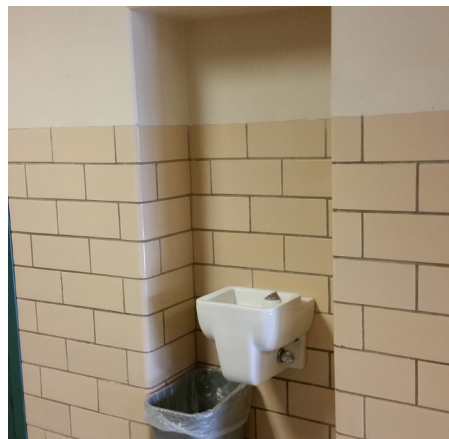
Water fountains throughout the school include new and old fixtures. Continuation of upgrades until all original water fountains are replaced will achieve compliance with building code (see Figure 63 and 64).

Figure 63 - Original drinking fountain

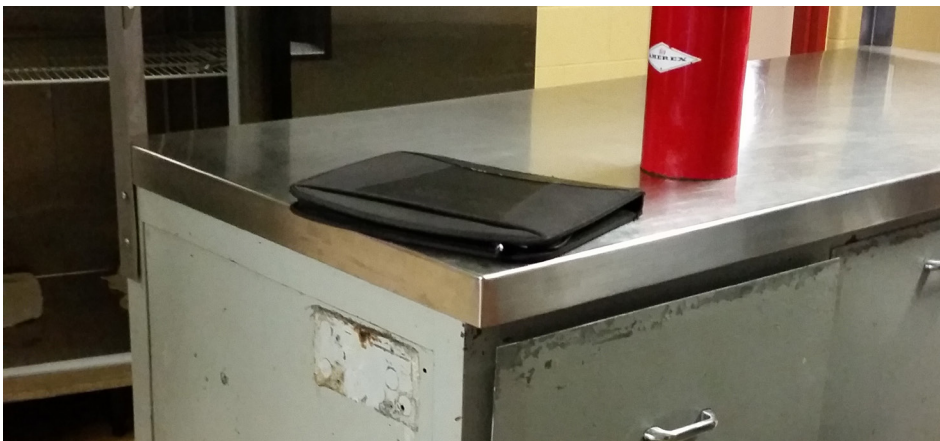
Figure 67 - Existing non-compliant food prep cart

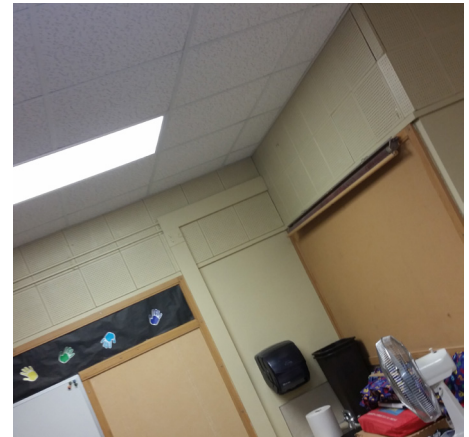
The presence of asbestos is anticipated in floor tile and wall locations throughout the building. Improvements to the building may require disturbance of these locations, and proper asbestos removal procedures will be required. The locations of these floor tiles include various supply closets on the northeast corner of the first floor and classrooms on the northeast second floor, wall locations in the northeast preschool classrooms, and Boy's Locker Room office. Hazardous material assessments should be scheduled in conjunction with any future renovation work within these respective areas (see Figures 69, 70, 71, and 72). Without an official hazardous material inventory completed by a licensed hazardous material inspector, total inventory and costs cannot be determined at this time.

Figure 69 - Potential asbestos containing materials in walls

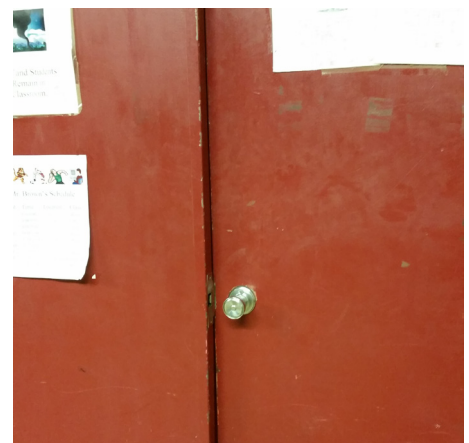
Figure 73 - Knob style door hardware

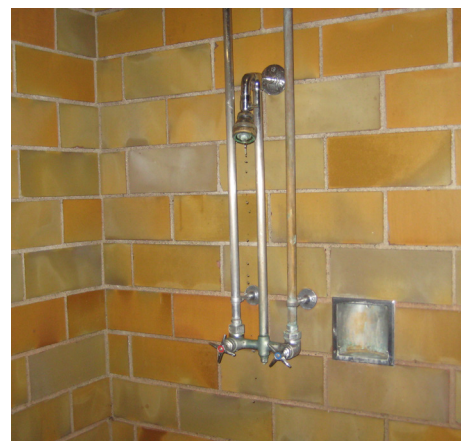
The restroom group near the Wood and Metal Shop, Office, and on second floor have old plumbing and fixtures that appear to be in need of replacement (see Figure 78). There is a shower in the Locker Room, and a toilet adjacent to the First Grade Room that leaks (see Figure 79).

Figure 79 - Leaking shower

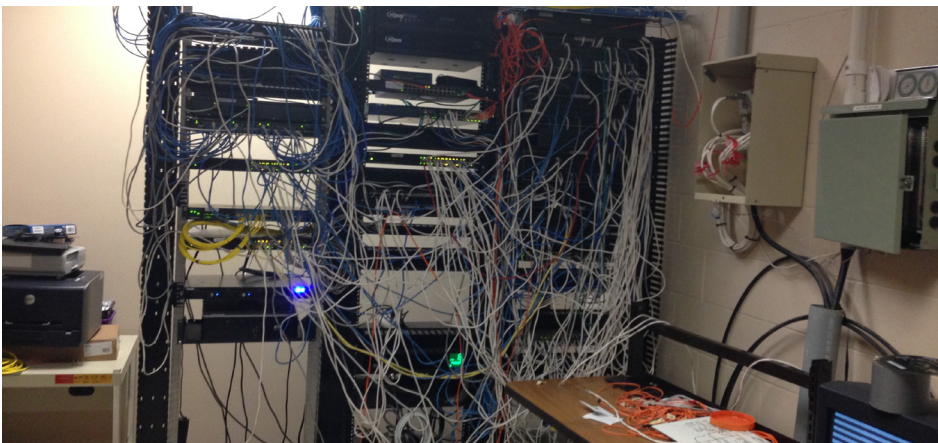
The IT Room near the Media Room has a large heat gain from equipment located in it which will need a mini split system to provide cooling. (see Figures 92 and 93). The IT Area over heats due to added equipment and no year-round cooling available. If the door is not propped open, overheating can damage equipment.

Figure 92 - Existing server rack

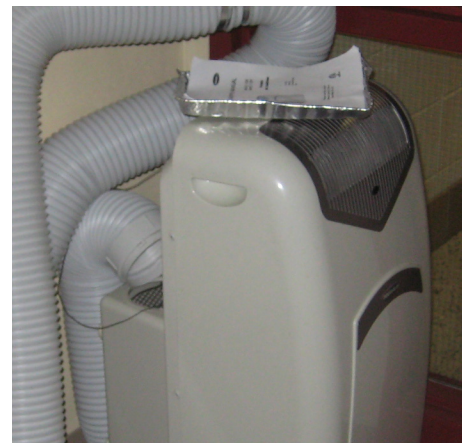
Figure 93 - Portable cooling unit

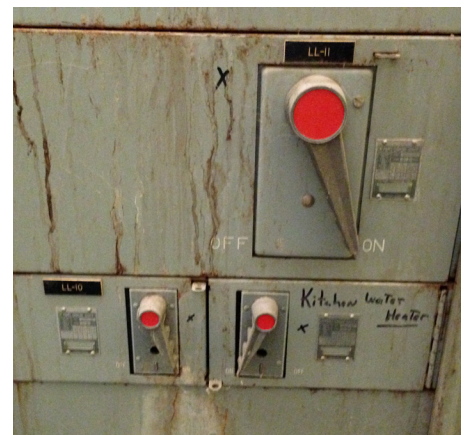
Figure 95 - Original electrical service with water stained cabinet
