FACILITY ASSESSMENT REPORT SPRINGFIELD PUBLIC SCHOOLS

Springfield, Minnesota

February 16, 2016

Project #16-18829

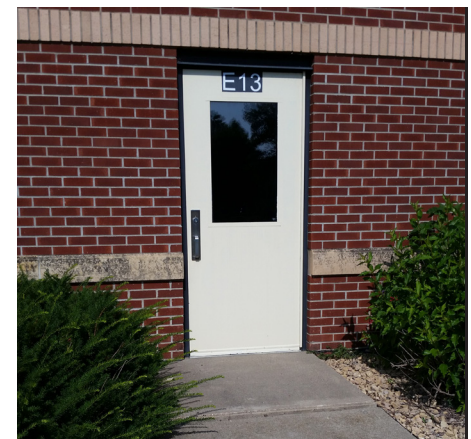
Figure 7 - Entrance at door E13

- At entrances E12 and E13, uneven concrete is an accessibility concern for students entering the playground (see Figures 6 and 7).

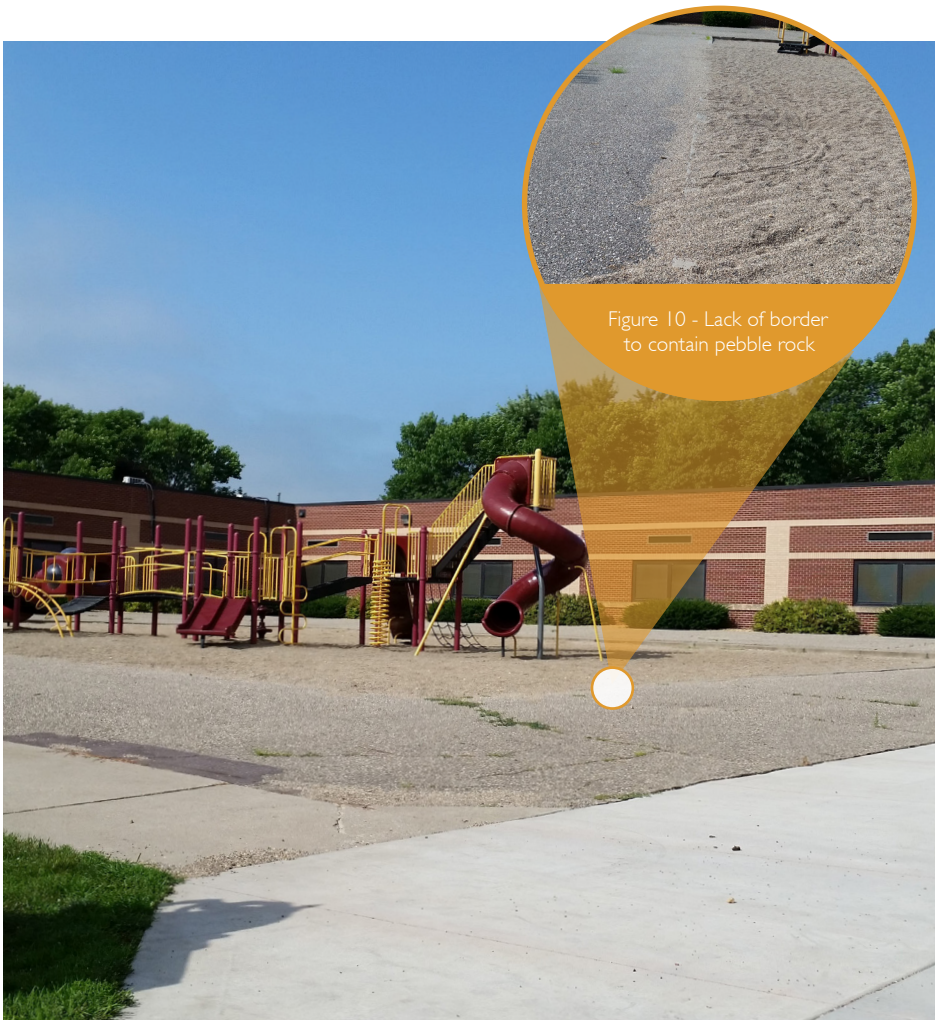
Figure 8 - Existing Elementary School playground

- The playground equipment designed for the Elementary School is in very good condition and promotes “Tiger Pride” using maroon and gold colors (see Figure 8).
- The surrounding asphalt is in poor condition with cracks, patching, and an overall uneven surface. There is an area near the north basketball hoop where an 8” hole is marked by a cone. This hole poses a safety concern to students playing in that area (see Figure 9).

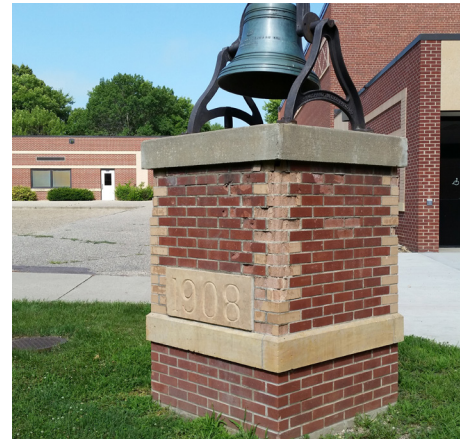
Figure 11 - Memorial Bell

Located near the playground is a small bell memorializing the establishment of Springfield Public Schools in 1908. The bell is in very good condition and provides appropriate historical appreciation. The masonry column that supports the bell shows brick deterioration and should be restored. The stone plaque that reads '1908' should be cleaned at the same time (see Figure 11).

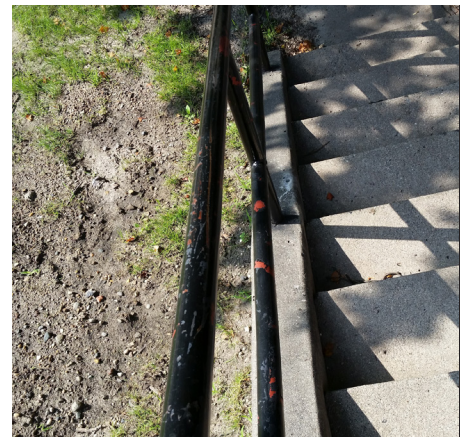
Figure 12 - Existing stair railing

The southeast corner of the Elementary School has an elevation change of about three feet. Stairs connect the concrete walks at both elevations. The stairs are in good condition and the railing is structurally sound but has areas of chipped paint (see Figure 12).

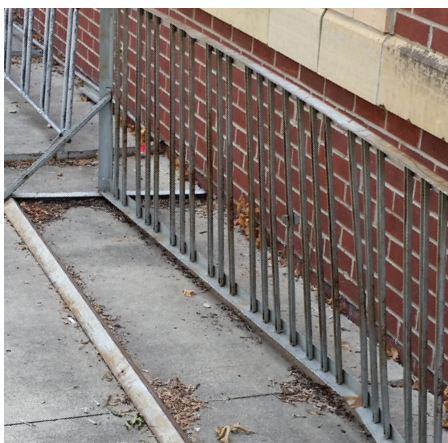
Figure 13 - Existing bike racks

The west side of the building has two bicycle racks for students to secure their bikes during the school day (see Figure 13). The racks are bent and rusting. To provide students with a safe place to lock their bikes, two new racks should be installed. Set-in ground racks will provide a reliable long lasting solution.

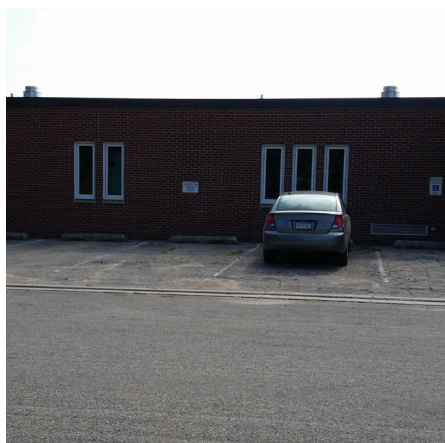
Figure 14 - West side parking area

On the west side of the building there is a small parking lot with six stalls. The pavement and striping are in poor condition, and the lot is in need of repaving. The concrete curbs at the front of each stall are in good condition and can be reinstalled after new pavement installation (see Figure 14).

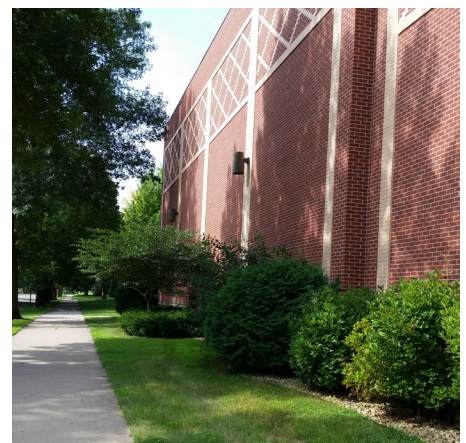
Figure 15 - Existing landscaping

Landscaping around the building, including bushes, a rock bed, and trees, is in very good condition and helps the school blend well into the surrounding residential neighborhood. Minimal continued maintenance of the landscaping will provide the site with a clean and well-kept appearance (see Figure 15).

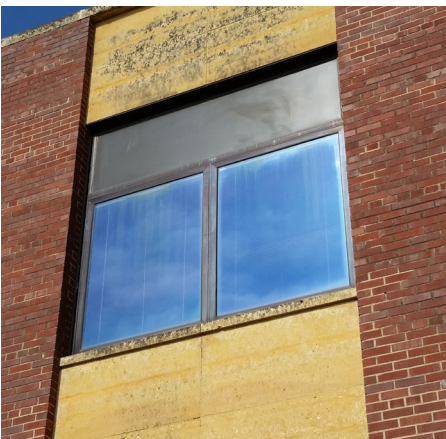
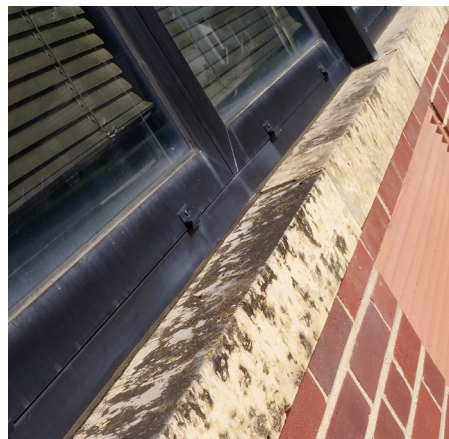
The exterior building material is a combination of several varieties of colored brick and stone block (see Figures 16, 17, and 18). The majority of the brick is in good condition. Most stone is also in good condition, however, it was noted that stone in several locations is in need of cleaning (see Figures 19 and 20). On the west side of the building at the gym, stone blocks are installed at the ground elevation. One corner stone is deteriorated and should be replaced (see Figure 21). All other stone appears to be in good condition.

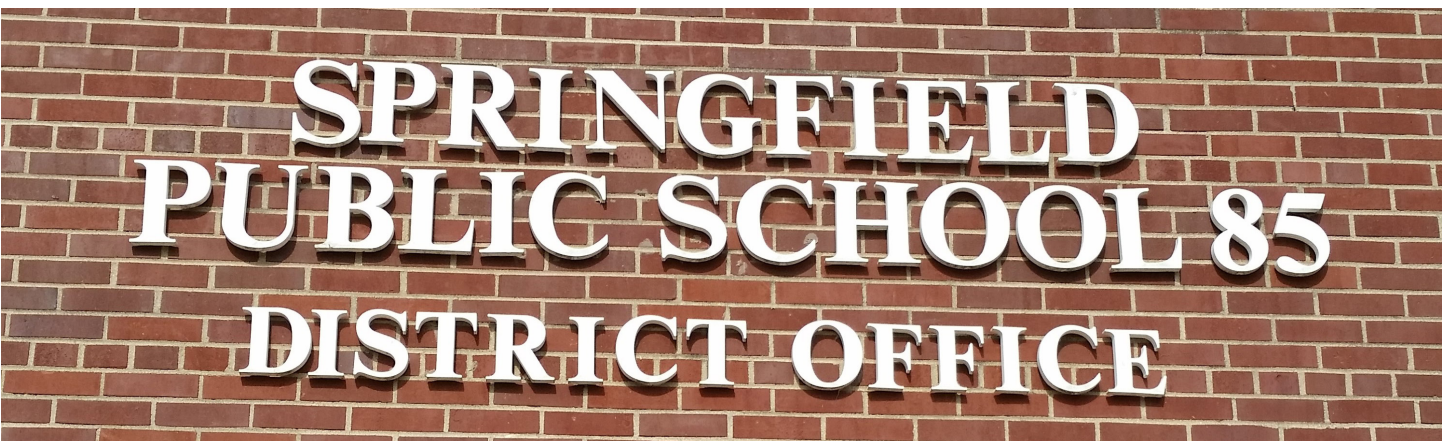
Figure 29 - Existing building signage

Building signage appropriately identifies the different functions of the building. Signage consists of white lettering on the face of brick walls. All signage is in excellent condition and requires minimal cleaning (see Figure 29).

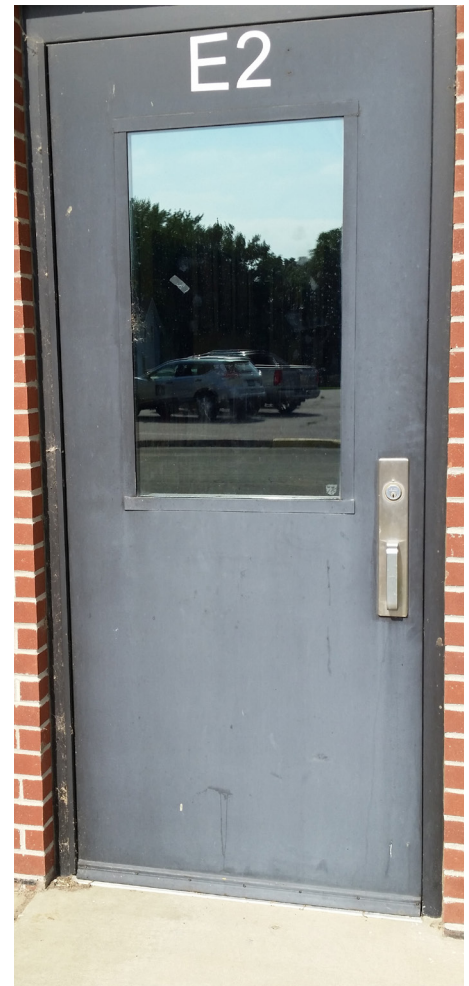
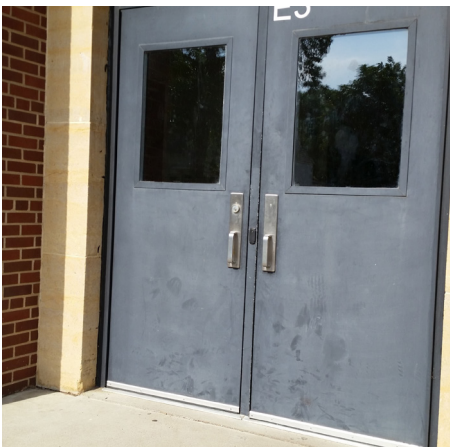
Exterior doors are constructed with hollow metal frames and glass lites. Overall, exterior doors appear in fair condition with minimal rusting. All doors are faded due to sun exposure and would benefit from new paint (see Figures 30 and 31). It should be noted that Door W8 specifically shows signs of rust and the handle on the northernmost door is damaged. Door W8 should be replaced (see Figure 32).

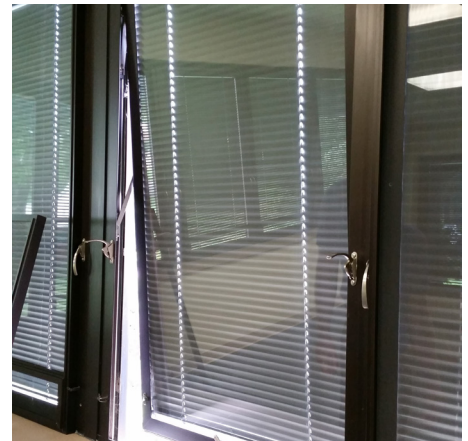
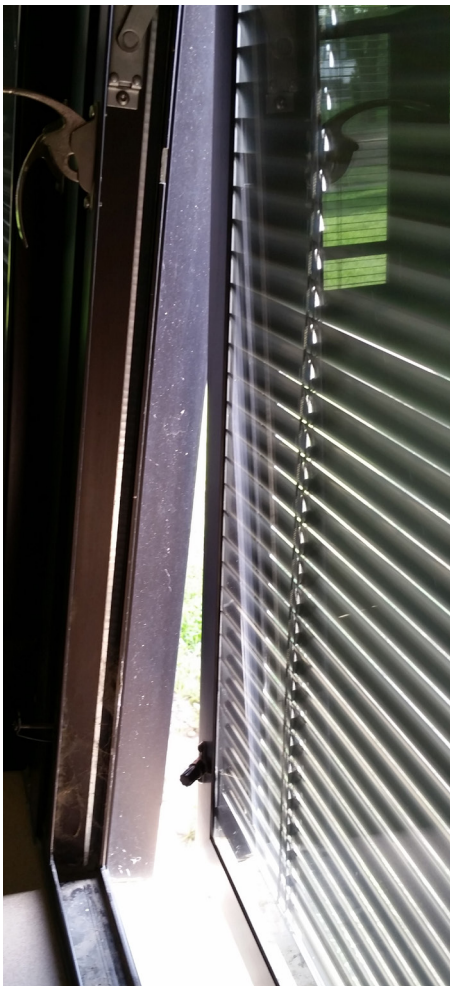
The majority of windows in the school are operational aluminum windows. Most appear to be in working condition with no signs of rust, broken glass, or deterioration. School personnel identified some leaking windows due to incomplete sealing. Seal replacement at these locations is recommended (see Figures 34 and 35). Additionally, hardware repair is needed at several windows throughout the facility.

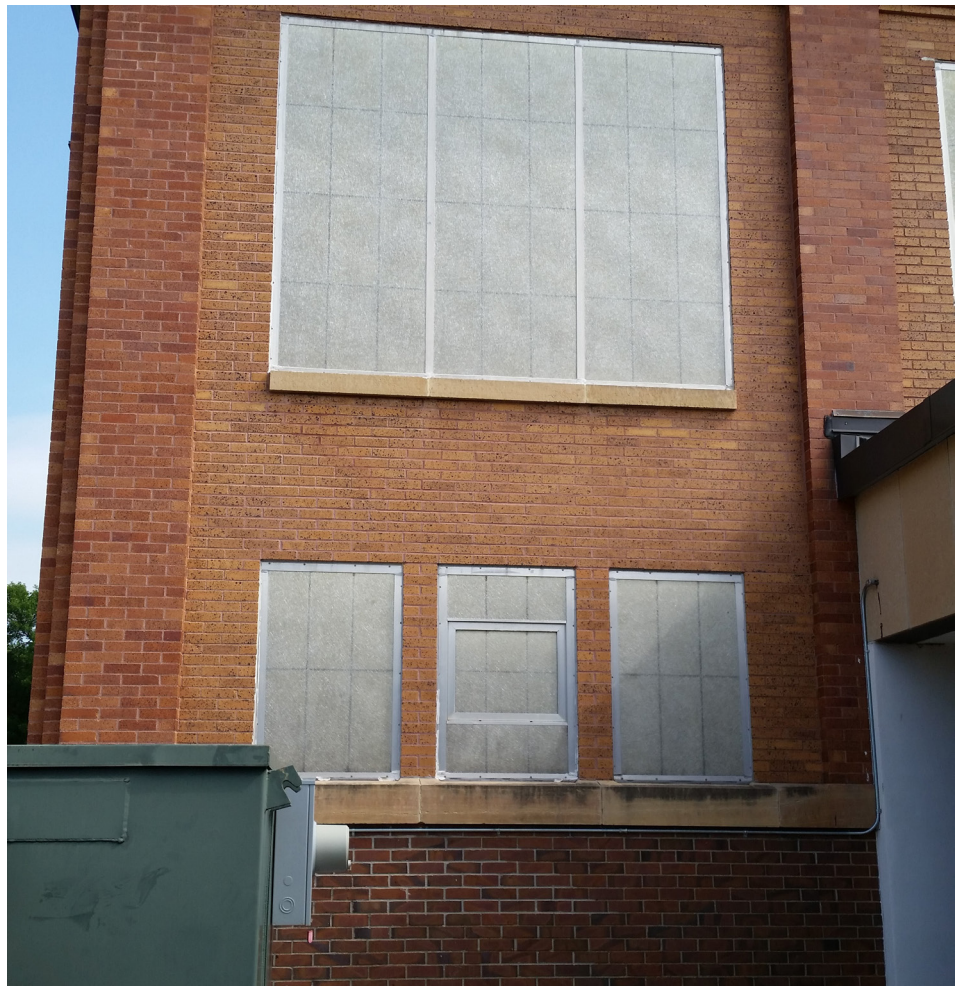
Figure 36 - Kalwall window type

A second window type is a Kalwall system which is located in the Elementary Gym. Kalwall is sandwiched fiberglass reinforced polyester panel. This particular window type is an older system and inefficient for heat retention. Replacement of this window type would result in better control of temperature in the gymnasium and provide day lighting in the gym (see Figure 36).

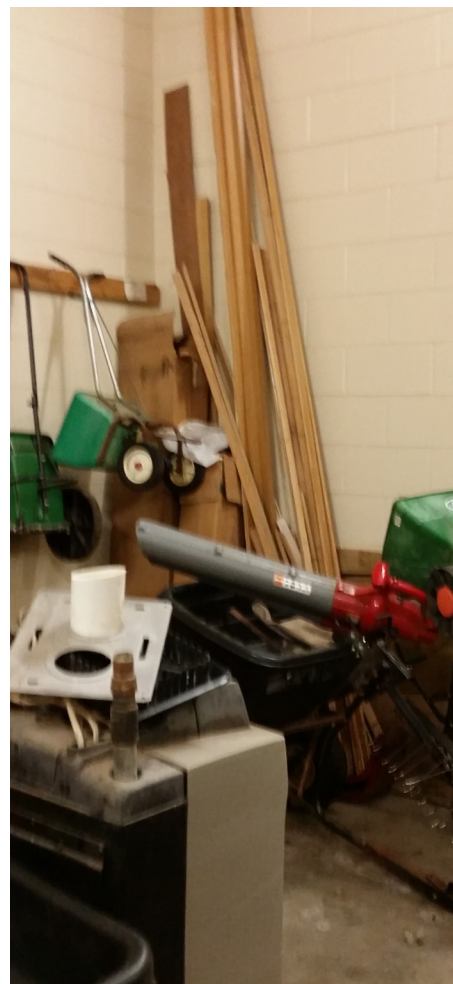
Figure 37 - Equipment stored in facility maintenance area

The facility maintenance area in the north wing would benefit from the addition of storage shelves to make the area safer for employees and ensure hazardous materials are stored properly (see Figure 37). The athletic concession stand is in good condition, however, all equipment in this area should be upgraded from laminate to stainless steel (see Figure 38).

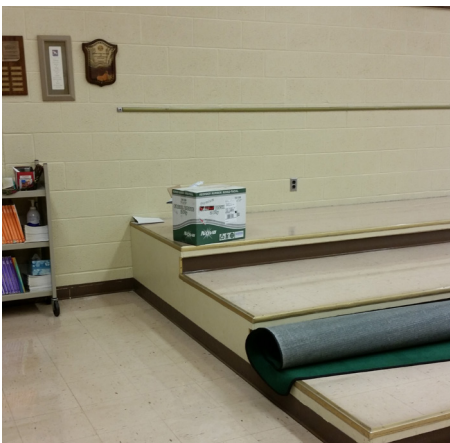
Figure 41 - Choir risers

The Music Room on the first floor includes a choir riser system that requires a guardrail for safety when above the finished floor level (see Figure 41). The Choir Room has acoustical panels on the wall to absorb sound. The panels are outdated and could use an upgrade. (see Figure 42).

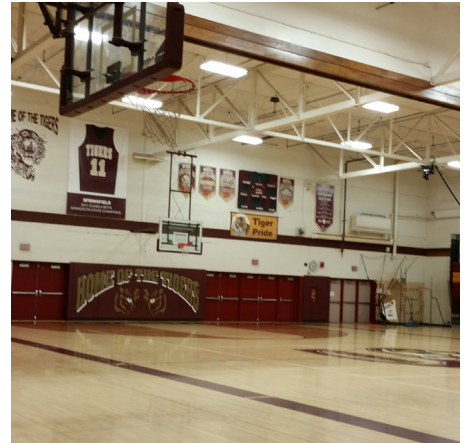
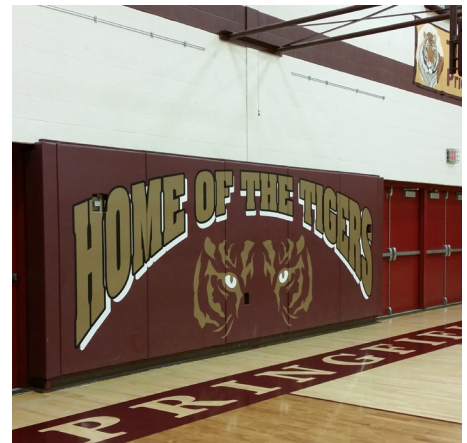
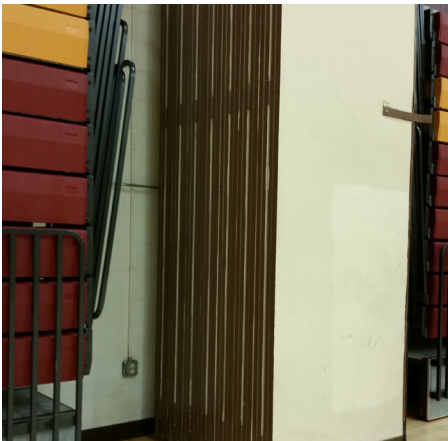
The main gym for the High School is located centrally in the building. Improvements were recently made with the replacement and installation of new plastic viewing bleachers. The wood floors in the gym are in excellent condition. There is a folding curtain wall that separates the gym into two smaller areas. This curtain is in low performing condition and should be replaced within the next five to ten years (see Figures 44, 45, and 46).

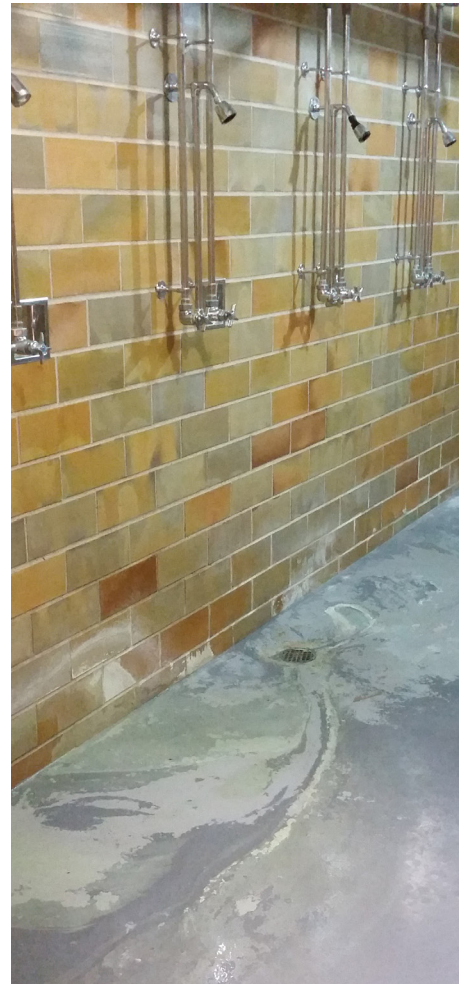
Figure 49- Boy's Locker Room showers

The shower area is located in a separate room accessed from the main locker room area. The flooring is sloped toward a drain allowing water to drain properly from the showers. The concrete floor and tile walls in the shower area could be upgraded (see Figures 49 and 50). The boy's locker room shower area does not meet current ADA codes. The entry door into the shower area is currently too narrow to accommodate accessibility. ADA codes also require reconfiguration of shower head locations. Floor drain locations will need to be reconfigured if shower head locations move, a trench drain is recommended.

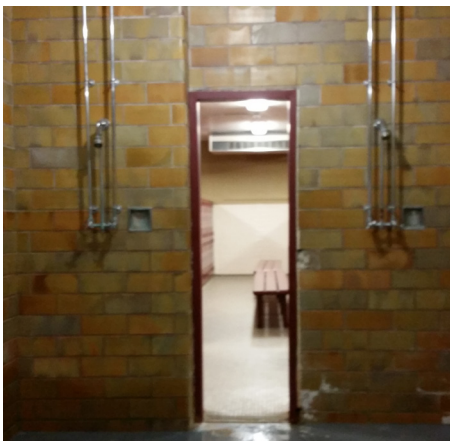
Figure 50 - Boy's Locker Room showers

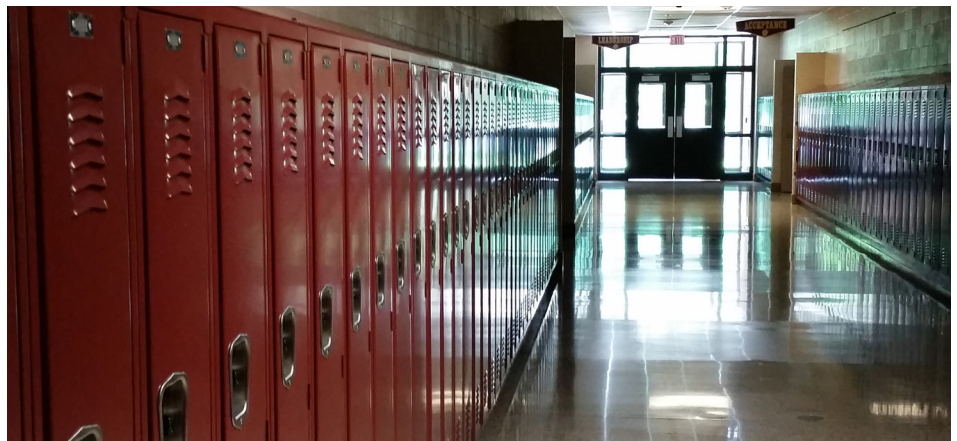
The Elementary School wing (south addition) is one of the newest additions. The hallways and offices are also in excellent condition (see Figure and 51). The classroom finishes are all in excellent condition with the exception of several classrooms that would benefit from carpet replacement (see Figure 52).

Figure 51 - Elementary hallway

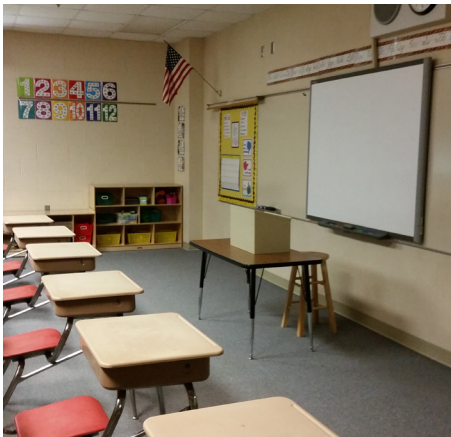
Figure 52 - Elementary classroom

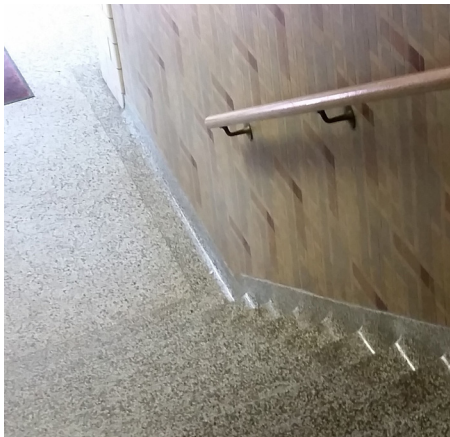
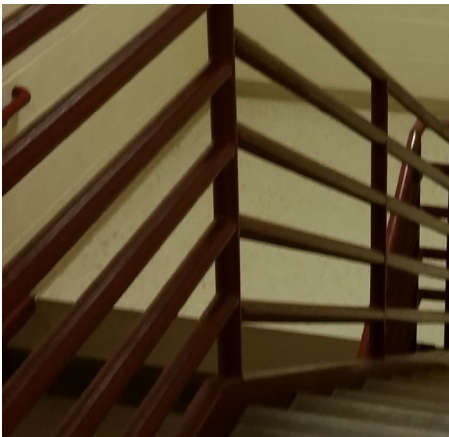
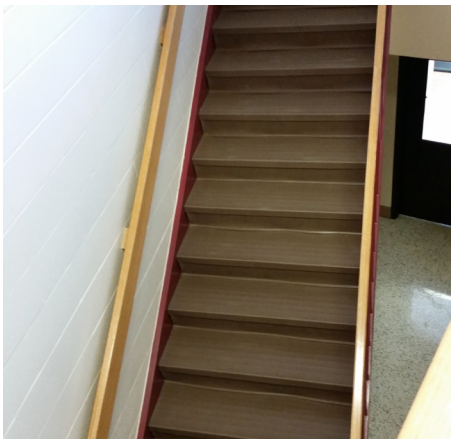
The stairway on the south wing of the building is in excellent condition. The rubber treads on the stairs are in nearly new condition and do not require modification (see Figures 53, 54, and 55).

Figure 53 - Existing stairwell

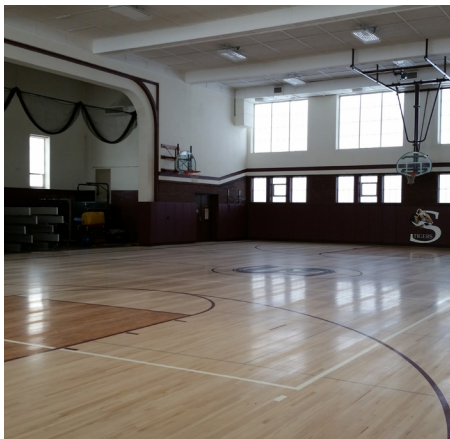
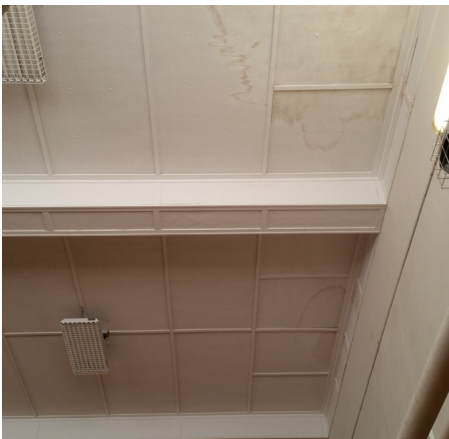
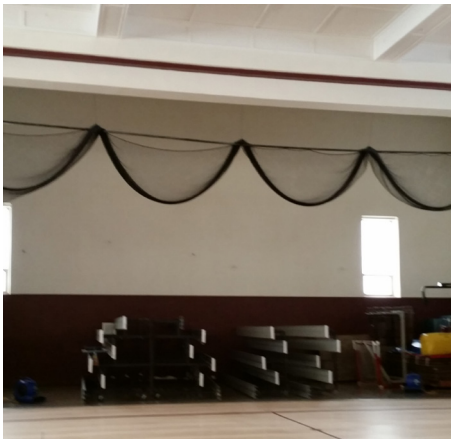
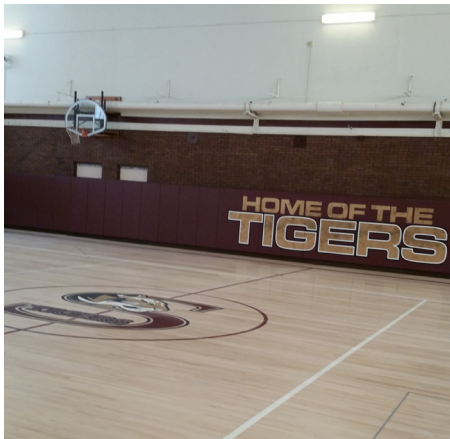
The smaller gym used for the Elementary School students is one of the oldest areas of the building. Renovations have been made to this area to update the space with school branding (see Figures 56, 57, 58, and 59). The windows in this area need to be replaced as mentioned in the exterior category (see Figure 60).

Figure 56 - Elementary Gymnasium

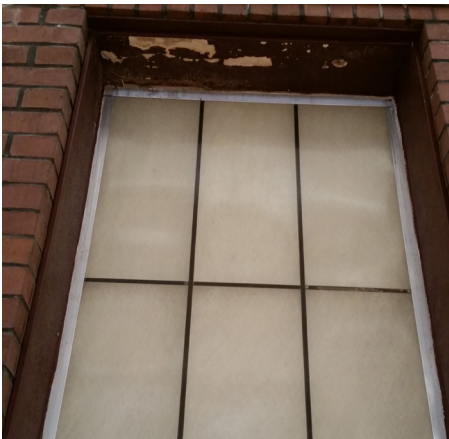
Figure 60 - Kalwall windows in Gymnasium

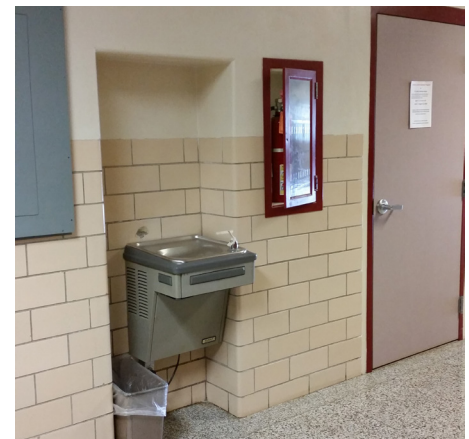
Water fountains throughout the school include new and old fixtures. Continuation of upgrades until all original water fountains are replaced will achieve compliance with building code (see Figure 63 and 64).

Figure 64 - Updated electric water cooler

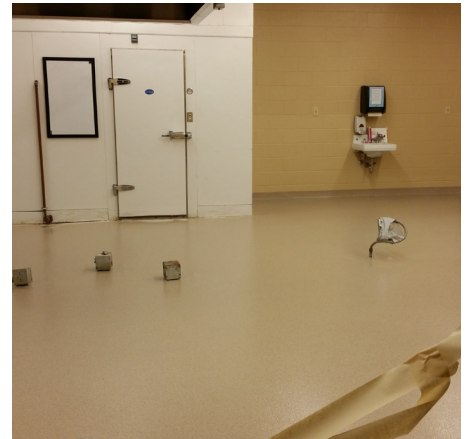
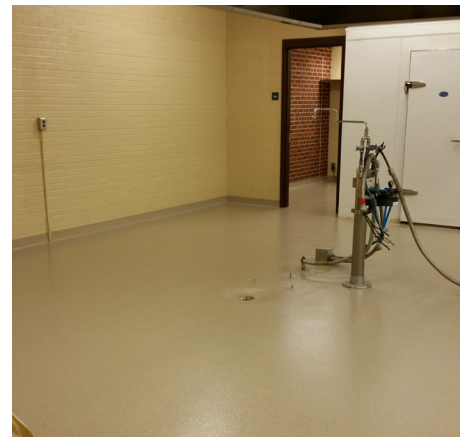
The Kitchen was upgraded during the summer of 2016 with new flooring (see Figures 65 and 66). Due to construction, ISG was only able to view the interior of the space from outside of the kitchen. The new flooring installed in the kitchen was well done and will be a quality improvement for the school. There was a food prep cart in the cafeteria that had painted metal cabinetry under the counter top, this not code compliant and should be replaced with a full stainless steel prep stand (see Figure 67). The ACT in the kitchen is perforated and by code needs to be a hard washable type. Replacement of ceiling grid will bring it up to code (see Figure 68).

Figure 65 - New kitchen flooring

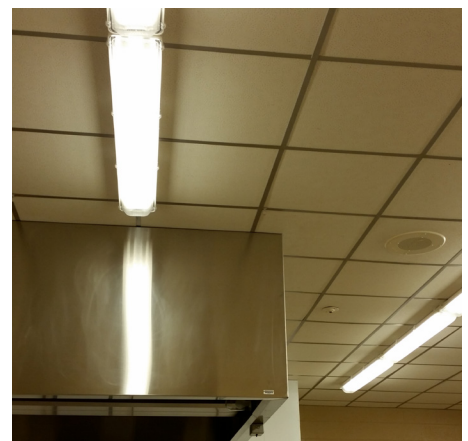
Figure 68 - Existing kitchen ACT

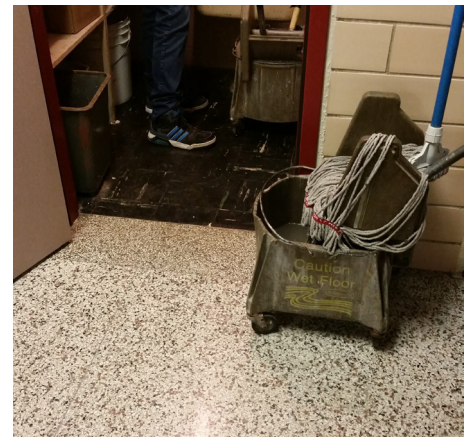
The main District office is located on the first floor of the north wing. The office was recently renovated and provides the District with adequate space to operate efficiently. A storage closet in the office has 9x9 floor tile that poses a concern for asbestos. See the Hazardous Material Conditions section for further considerations.

Figure 70 - 9x9 floor tile in janitor closet

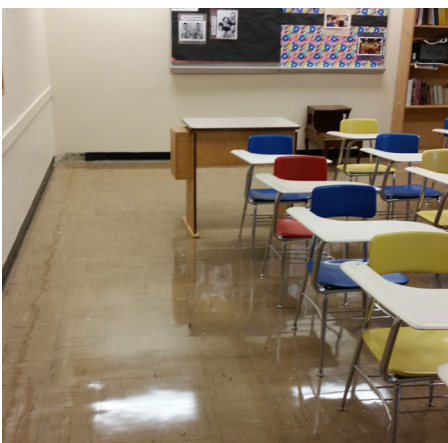
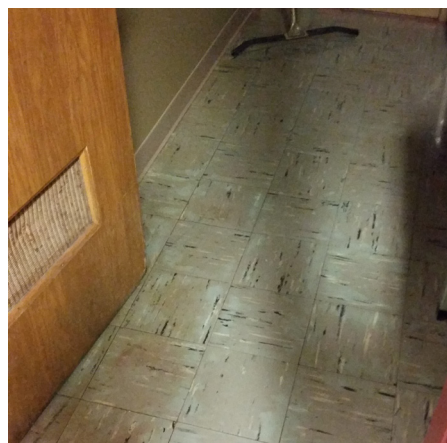
The presence of asbestos is anticipated in floor tile and wall locations throughout the building. Improvements to the building may require disturbance of these locations, and proper asbestos removal procedures will be required. The locations of these floor tiles include various supply closets on the northeast corner of the first floor and classrooms on the northeast second floor, wall locations in the northeast preschool classrooms, and Boy's Locker Room office. Hazardous material assessments should be scheduled in conjunction with any future renovation work within these respective areas (see Figures 69, 70, 71, and 72). Without an official hazardous material inventory completed by a licensed hazardous material inspector, total inventory and costs cannot be determined at this time.

Figure 71 - Typical 9x9 floor tile

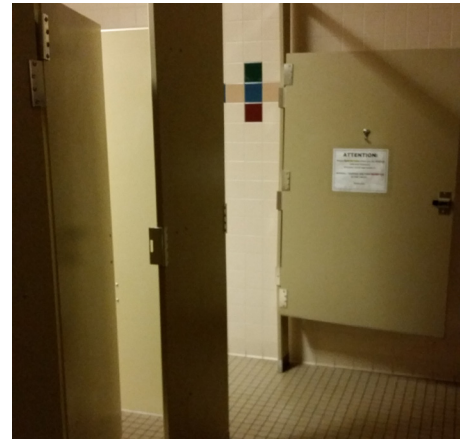
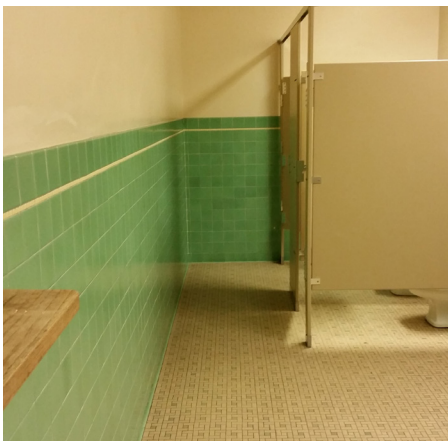
Almost every restroom lacks accessibility in accordance with ADA standards. The last stall in the restroom, which is commonly considered the accessible stall, should be 60" wide by 78" deep. To accommodate these dimensions, revisions of the restroom layouts are needed (see Figures 74 and 75).

Figure 74 - Existing restroom configuration

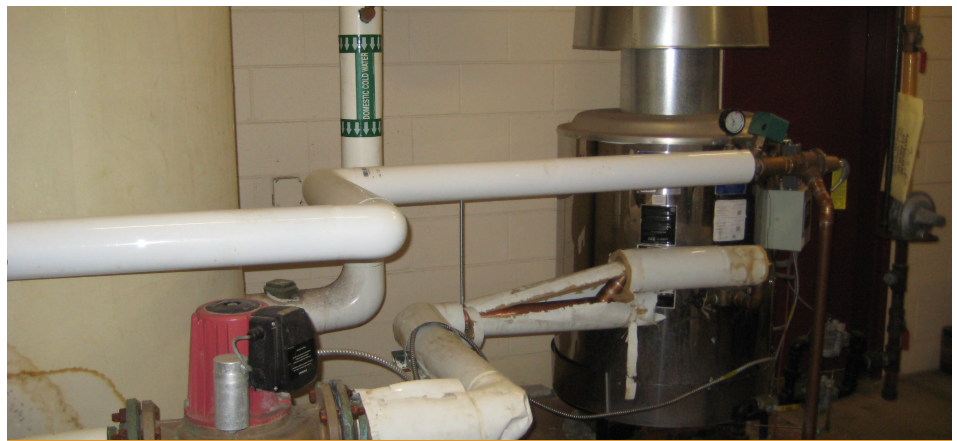
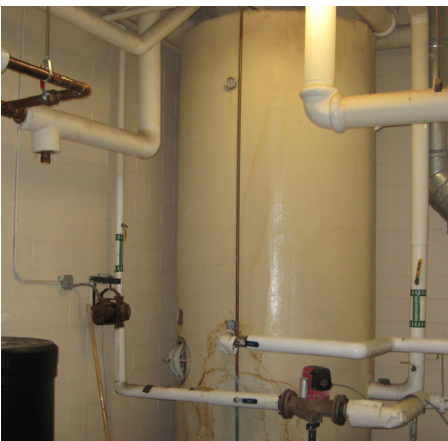
The water service comes into the facility in the Boiler Room. The water meter and service is a 3" line (see Figure 76). The building has a water softener located in the Boiler Room. The water heater is also located in the Boiler Room and consists of an approximately 500 gallon storage tank, 100,000 BTU boiler with circulation pumps, and building recirculation pumps (see Figure 77).

Figure 76 - Domestic hot water boiler

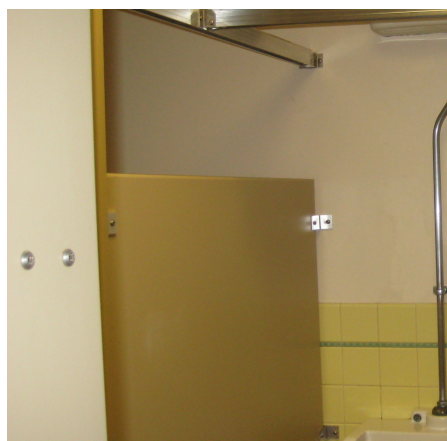
The restroom group near the Wood and Metal Shop, Office, and on second floor have old plumbing and fixtures that appear to be in need of replacement (see Figure 78). There is a shower in the Locker Room, and a toilet adjacent to the First Grade Room that leaks (see Figure 79).

Figure 78 - Restrooms with outdated fixtures

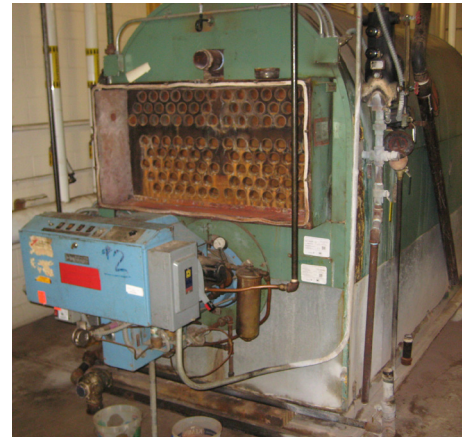
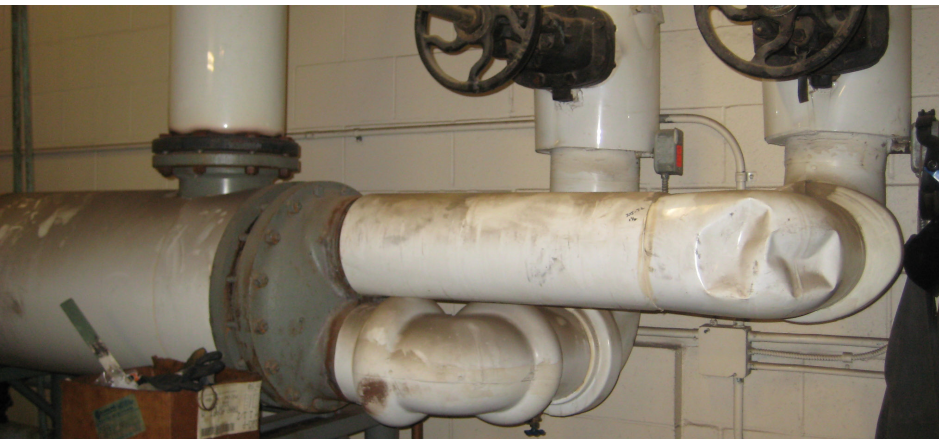
The building's heating is served by two, 5312 MGH steam boilers. There are a few smaller areas that use the steam heat but most of the steam is converted to hot water which is then pumped throughout the facility (see Figures 80 and 81). The boilers are dual fuel and typically fire with natural gas but when requested by the natural gas utility, they can be switched to operate with fuel oil (see Figure 82). There are portions of the school that are cooled. Those areas have direct expansion refrigerant systems (see Figures 83 and 84).

Figure 80 - Existing steam boiler

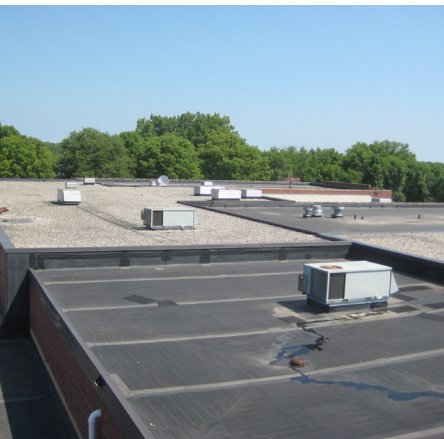
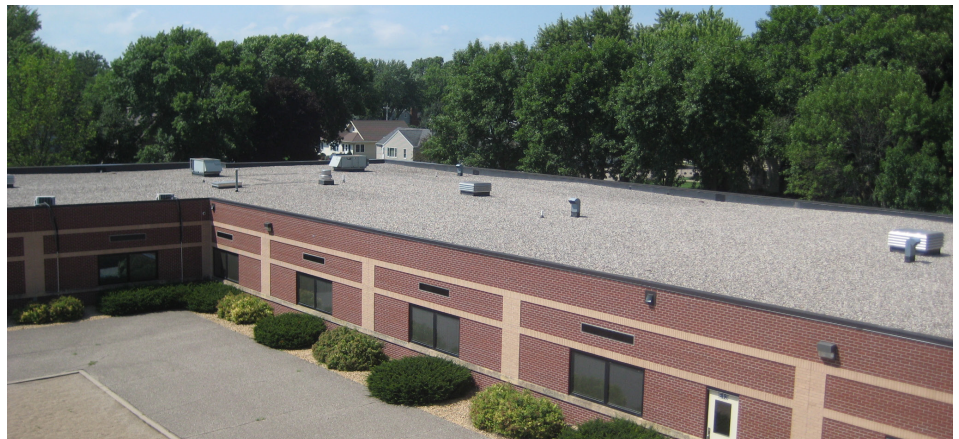
Figure 83 - Typical DX rooftop unit

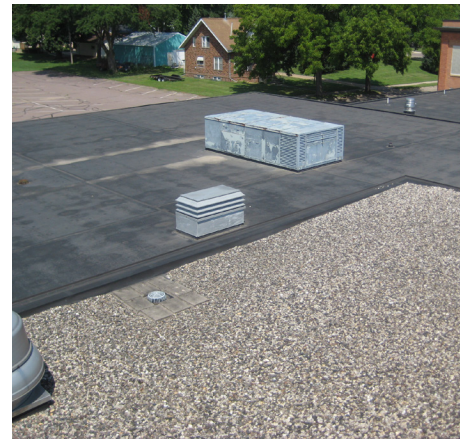
The Elementary School Office has a roof mounted air handler (see Figure 85). The Computer Lab has a roof mounted air handler. Classrooms have unit ventilators located along the outside wall of each room. One classroom was converted to a computer room in which two mini splits were added for cooling. On the day of the walk through the classroom had extreme high level of humidity that caused the floor to have condensation. A dehumidification system would address humidity for this entire wing.

Figure 85 - Rooftop unit

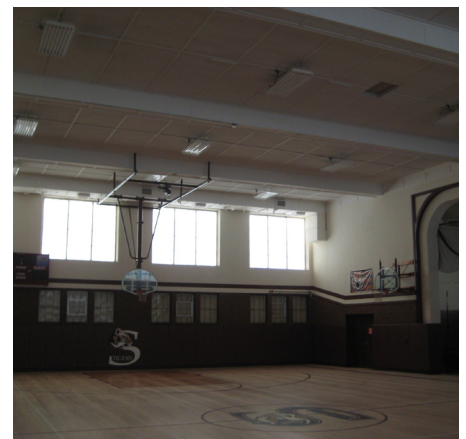
The Elementary Gym is served by two air handlers located in the northwest and southwest corners of the area above the storage and electrical rooms (see Figure 86).

Figure 86 - Gymnasium ductwork

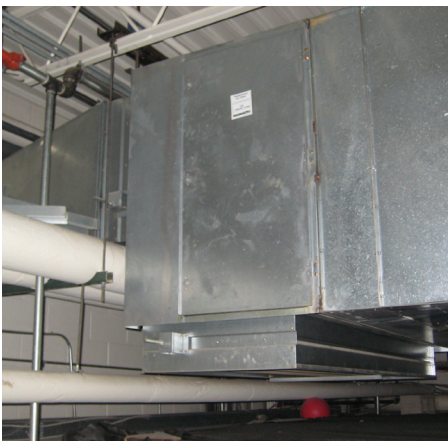
The Main Gym is served by two air handlers (see Figure 87) located in the northwest and southwest corners of the area above the storage and electrical rooms along with fin tube radiation along the north and south walls of the space. While on site there was a large pressurization difference between the gym and the auditorium corridor.

Figure 87 - Gymnasium air handling equipment

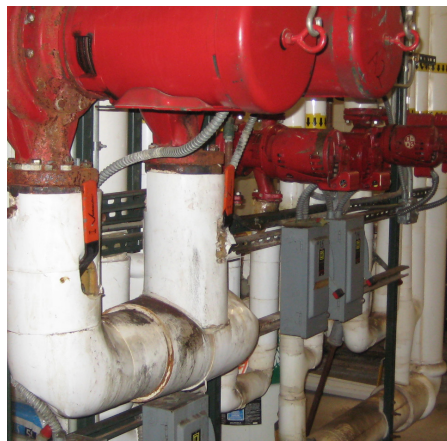
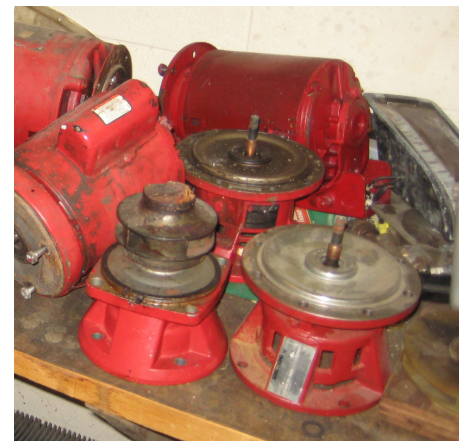
This area is served by roof mounted air handlers and indoor air handlers. The Grounds and Maintenance Room does not have an exhaust system. The exhaust is needed due to storage of gas power equipment and repairs being performed in the space. Since the facility still has areas where steam is being used, the boiler is steam type with a steam to hot water converter that supplies the majority of the facility. The boilers are fueled by both natural gas and fuel oil. The building hot water heater system consists of many pumps located in the building and at the air handler's rooms which creates

Figure 88 - Heating pumps

extra maintenance compared to a single pumping with Variable Frequency Drive (VFD) control (see Figures 88 and 89).

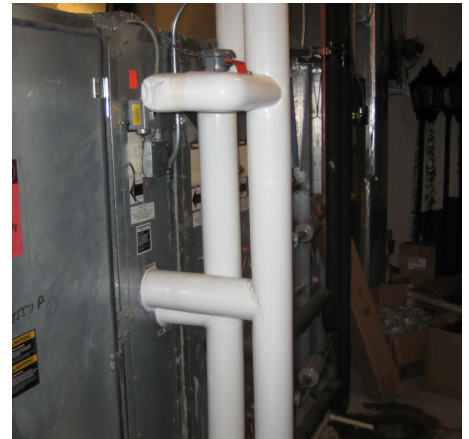
This area is served by indoor air handlers. The dimming rack located in the auditorium catwalk area overheats and should be placed in a separate room with better climate control (see Figure 90). A mini split system or exhaust system should then be added for climate control.

Figure 90 - Auditorium air handler

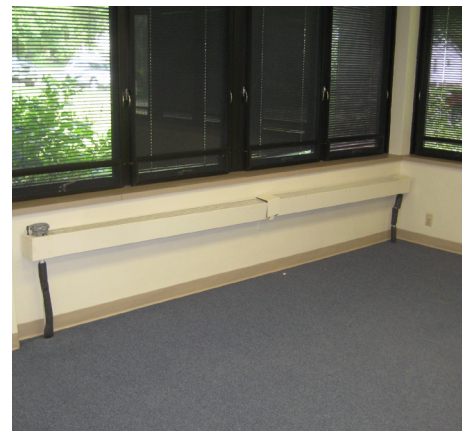
This area is served by indoor air handlers except for the special needs and ECFE rooms. They have fin tube radiation only (see Figure 91). These two rooms do not have any ventilation.

Figure 91 - ECFE Room - radiation heat only

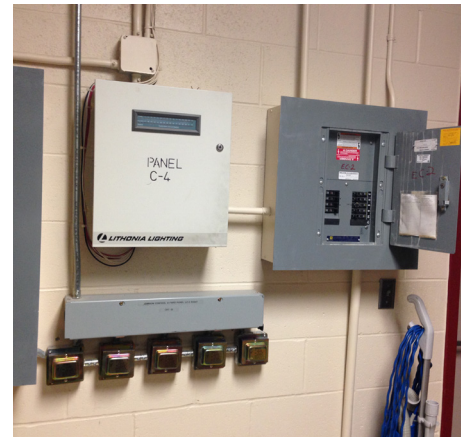
Figure 94 - Lighting control panel

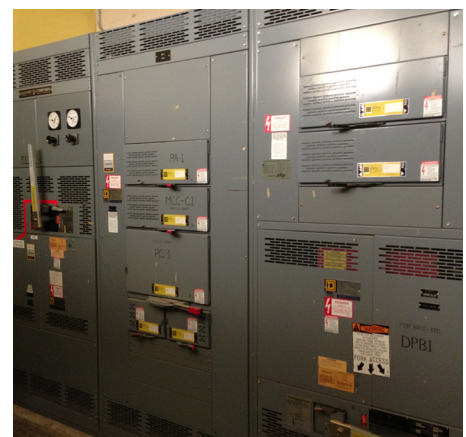
Figure 96 - Main electrical service

The interior lighting consists mainly of linear fluorescent T8 light fixtures. Generally, the light fixtures are in good to fair condition. Light levels are appropriate in corridors, gymnasiums, and classrooms. Linear fluorescent T8 light bulbs are efficient and still widely used and available. Common areas including main corridors, entries, and exterior lighting are controlled by a lighting control panel to automatically turn lights on/off. The lighting controls system could be expanded to include classrooms for additional energy savings. The lighting controls have exceeded their estimated useful lifespan but appear to still be functioning properly (see Figure 96 on previous page).
